**DRAFT ENVIRONMENTAL RESTORATION
RFCA STANDARD OPERATING PROTOCOL
FOR ROUTINE SOIL REMEDIATION
FY03 NOTIFICATION #03-12
IHSS GROUP 800-1**

September 2003

Figure 1
IHSS Group 800-1
Location Map
(As of August 26, 2003)

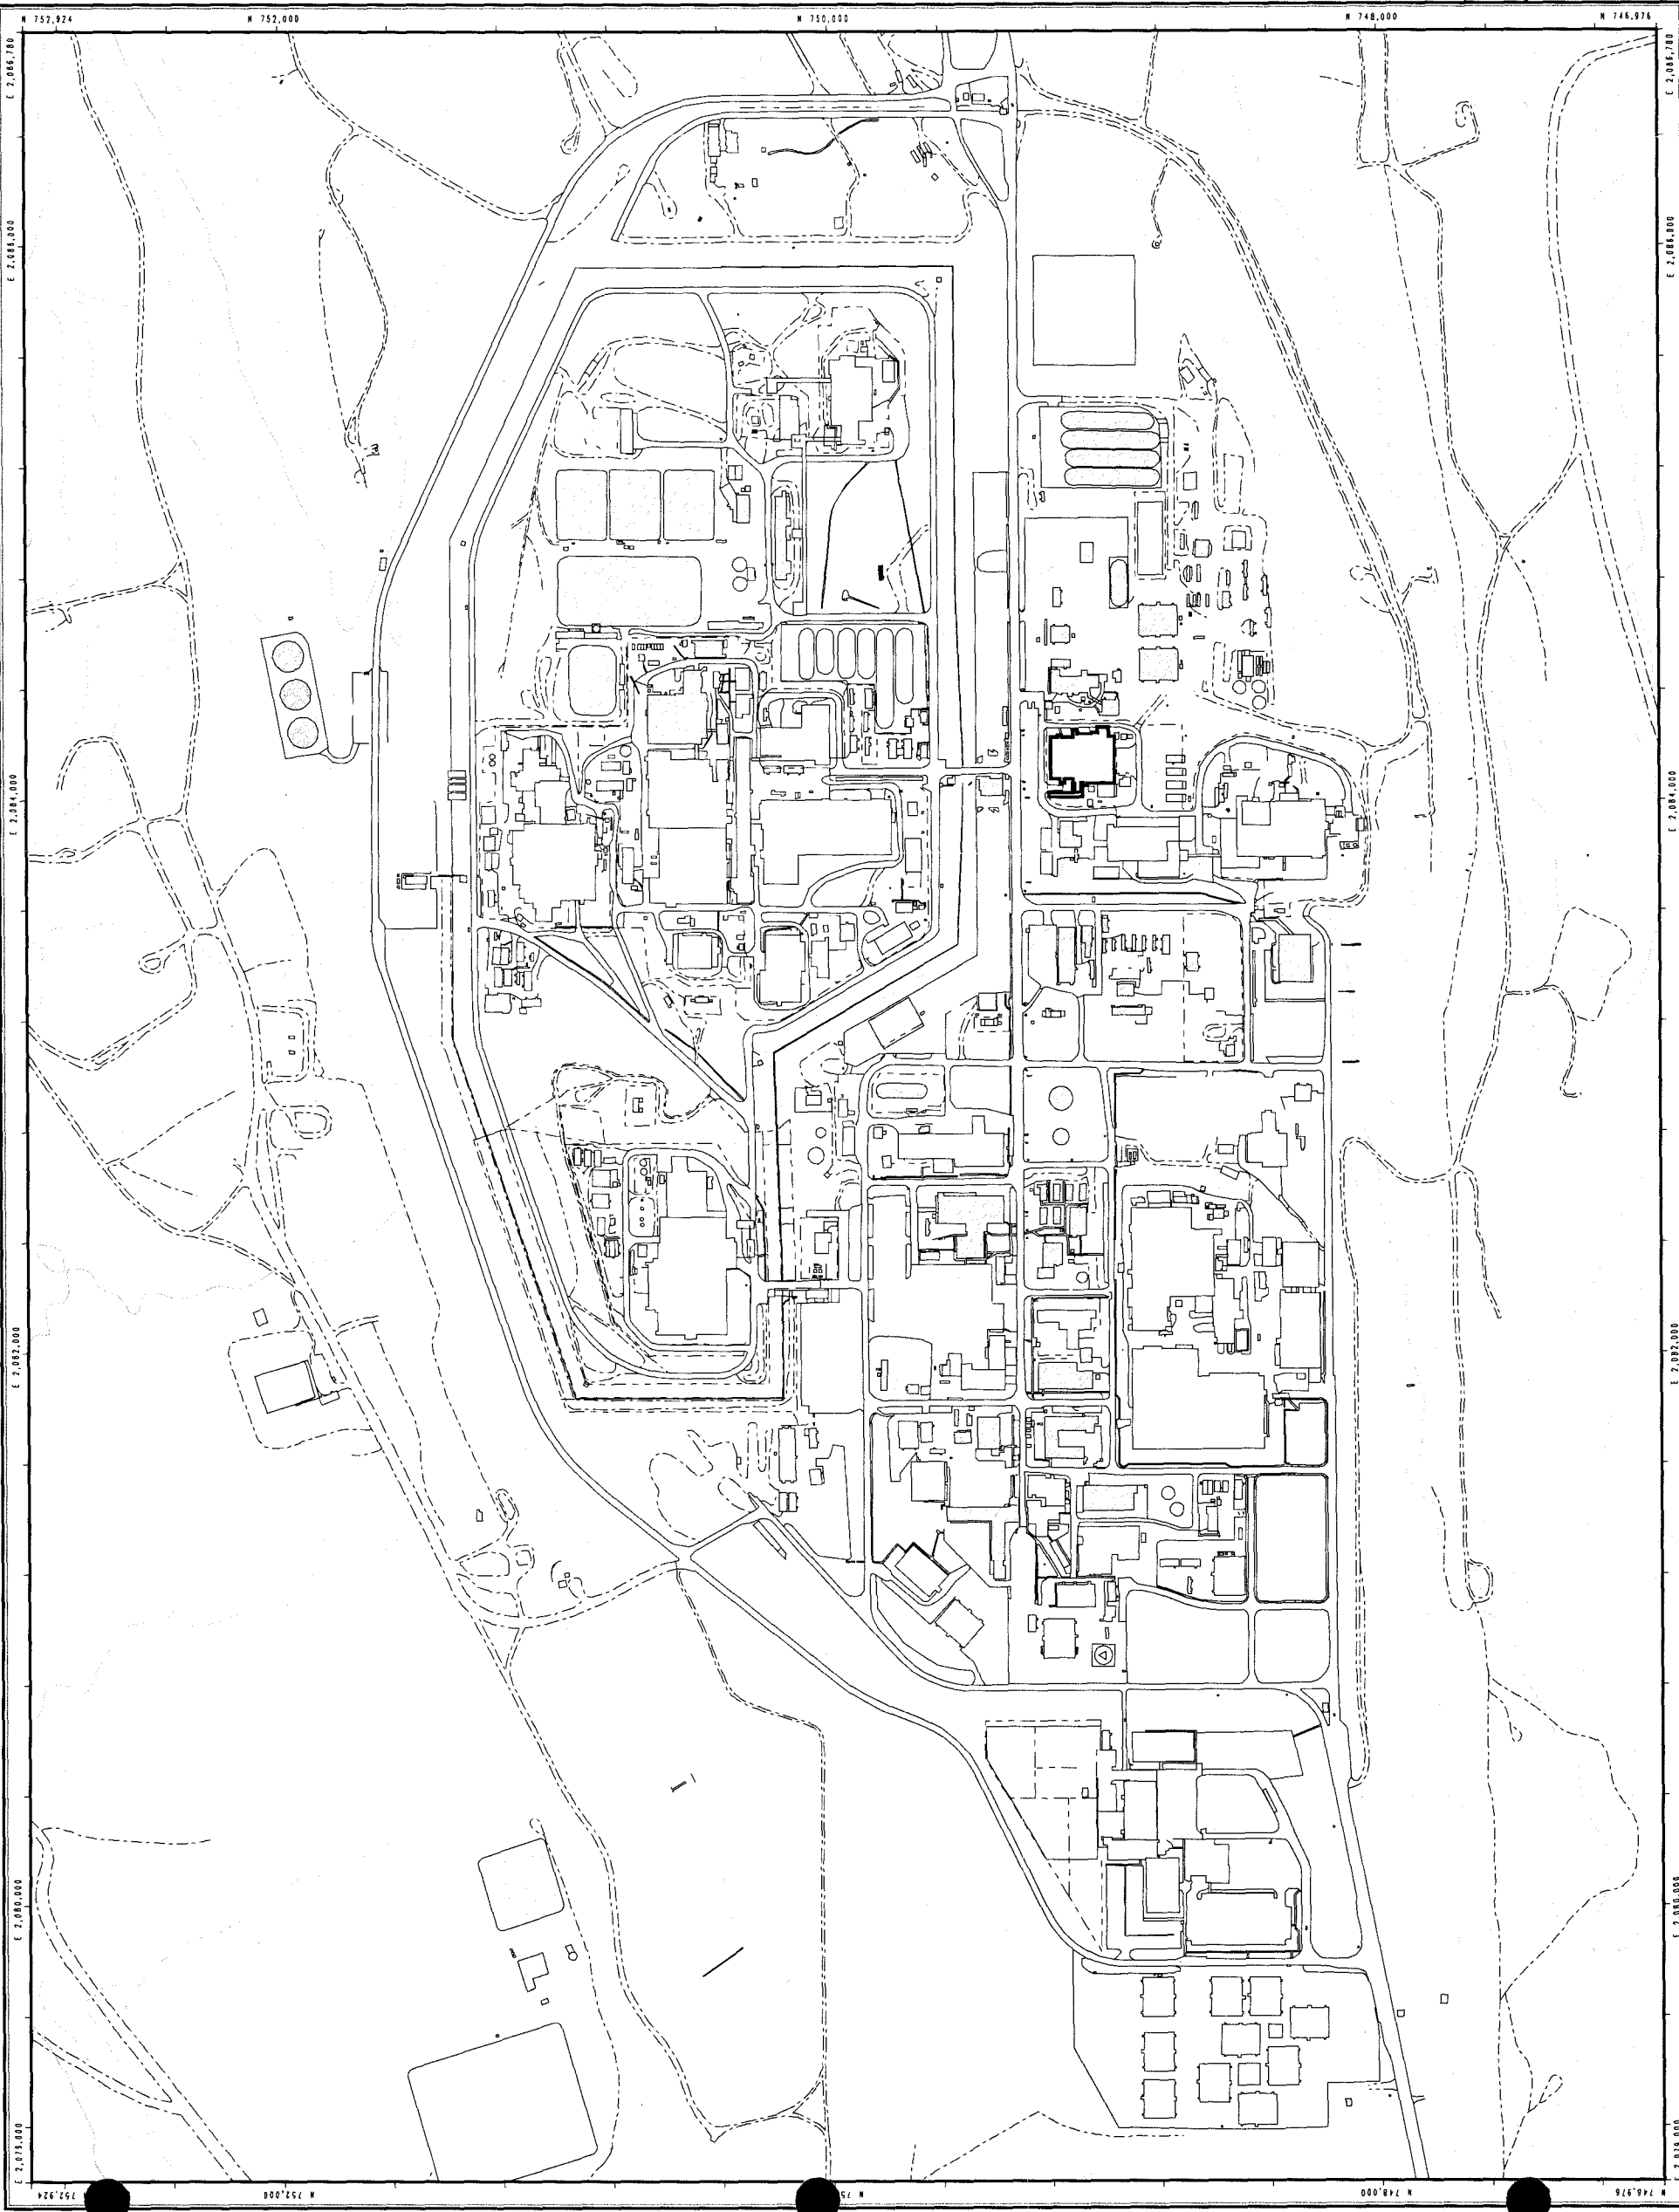
The IHSS Group is shown on Figure 1, and the proposed remediation sites covered under ER RSOP Notification #03-12 are listed in Table 1.

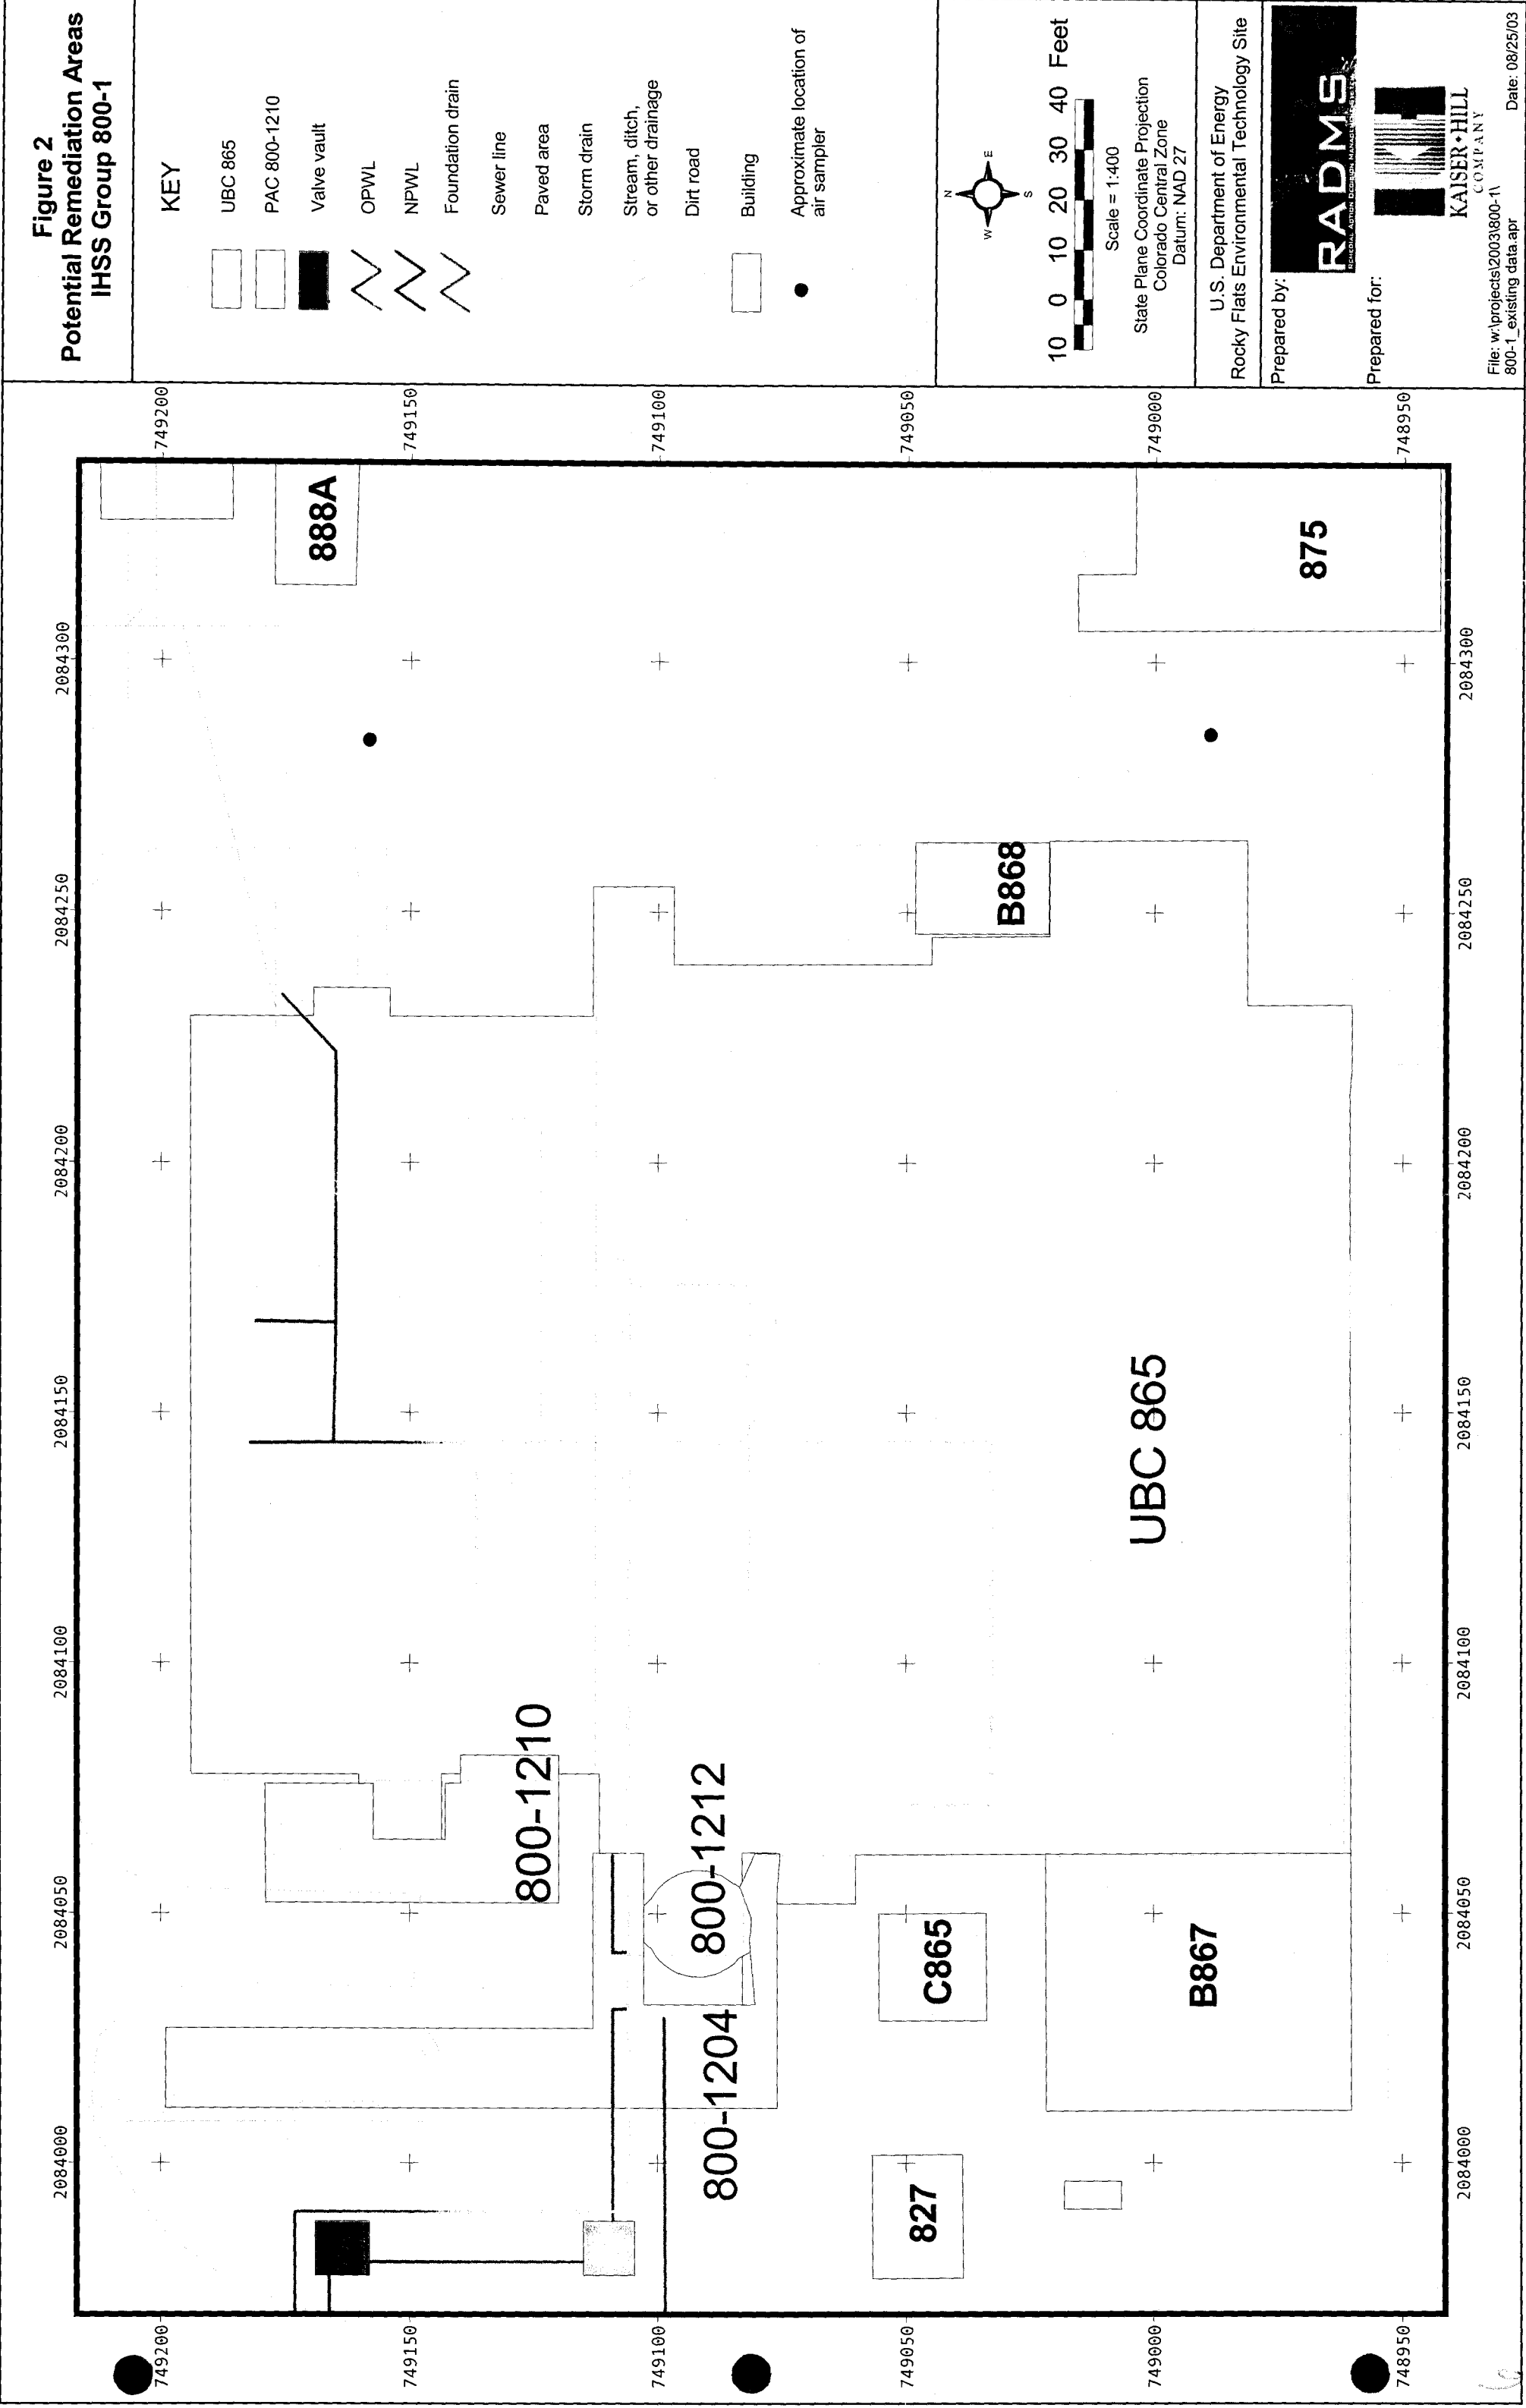
IHSS Group 800-1 includes UBC 865, Materials Process Building; PAC 800-1204, Building 866 Spill; PAC 800-1210, Transformers 865-1 and 865-2; PAC 800-1212, Building 866 Sump Spill; and IHSS 000-121 OPWL Tank 23. The PAC and UBC sites are shown on Figure 2.

Based on the PCOCs (Table 1 and Section 2.1) and the ER RSOP (DOE 2002a), it is anticipated that all contamination above RFCA ALs will be remediated. Figure 2 shows the potential remediation areas (PAC and UBC sites).

High-volume air samplers may be used at the remediation area consistent with work controls to determine airborne radioactivity concentrations. Approximate locations of air samplers are shown on Figure 2.

- UBC 865, Materials Process Building, currently consists of the Building 865 foundation slab and below-grade equipment pits and sumps. Building 865 was demolished to its main foundation slab during August 25 and 26, 2003. The slab is contaminated with depleted uranium (DOE 2001b). Prior to building demolition, the slab was sprayed with Instacote, and during demolition, gouges and openings in the slab were sprayed with fixative. Process waste drains penetrating the foundation were filled to grade with grout prior to building decontamination and decommissioning (D&D). Pipe conduit openings in the building slab were plugged and grouted at the foundation level. Original Process Waste Lines (OPWL), foundation drains, and other utilities are present under the slab (Figure 2). OPWL Tank 23 was previously removed (Verbal communication, Cameron Freiboth, August 25, 2003).

- PAC 800-1204, Building 866 Spill, and PAC 800-1212, Building 866 Sump Spill, consist of Building 866, which was constructed to house process waste collection tanks. Process waste was released to the environment over the life of the facility during tank-filling operations. The waste tanks, the secondary containment system, and the concrete sump pit are still present. The tanks were emptied and are no longer subject to RCRA regulation (Verbal communication, Steve Nesta, August 25, 2003). OPWL and New Process Waste Lines (NPWL) are associated with the building (Figure 2).
